August 1958

THE NAVAL
AVIATION
SAFETY
REVIEW
NAVAER-00-75-510

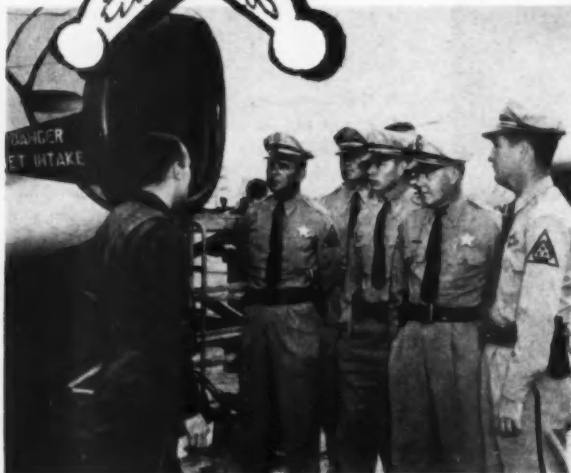
WATCH THAT JET INTAKE! LTJG Alan Bean explains to lawmen: "Stay away from the tail, the air intakes and guns. Go over the front part of the wing and work your way along it to the canopy."

Those were some of the things brought out to better enable lawmen to cope with the task of removing an injured pilot from a cockpit in a hurry. Police officers from the Florida Highway Patrol, Duval County, and local municipalities were shown methods of cockpit entry, how to unfasten or sever harnesses, and the proven technique of cracking open a canopy by chilling it with a CO₂ fire extinguisher before hitting it.

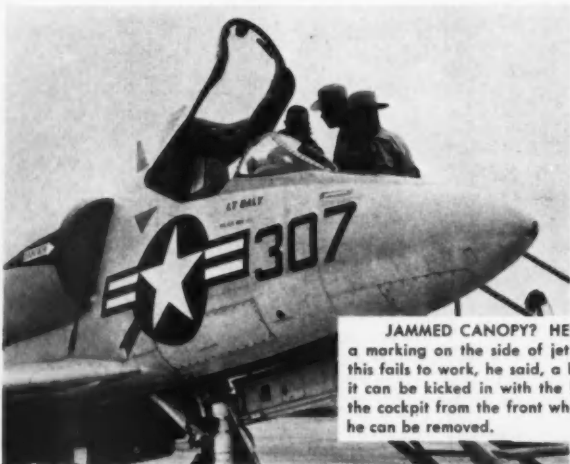
JAMMED CANOPY? HERE'S HOW—(Below) LTJG Gene Bordone tells patrolmen there is always a marking on the side of jet aircraft pointing to the emergency handle for releasing the canopy. If this fails to work, he said, a blast from a CO₂ fire extinguisher will normally freeze the canopy where it can be kicked in with the heel of a shoe. Navy crash crewmen also showed them how to straddle the cockpit from the front when removing the pilot and the straps that must be cut or released before he can be removed.

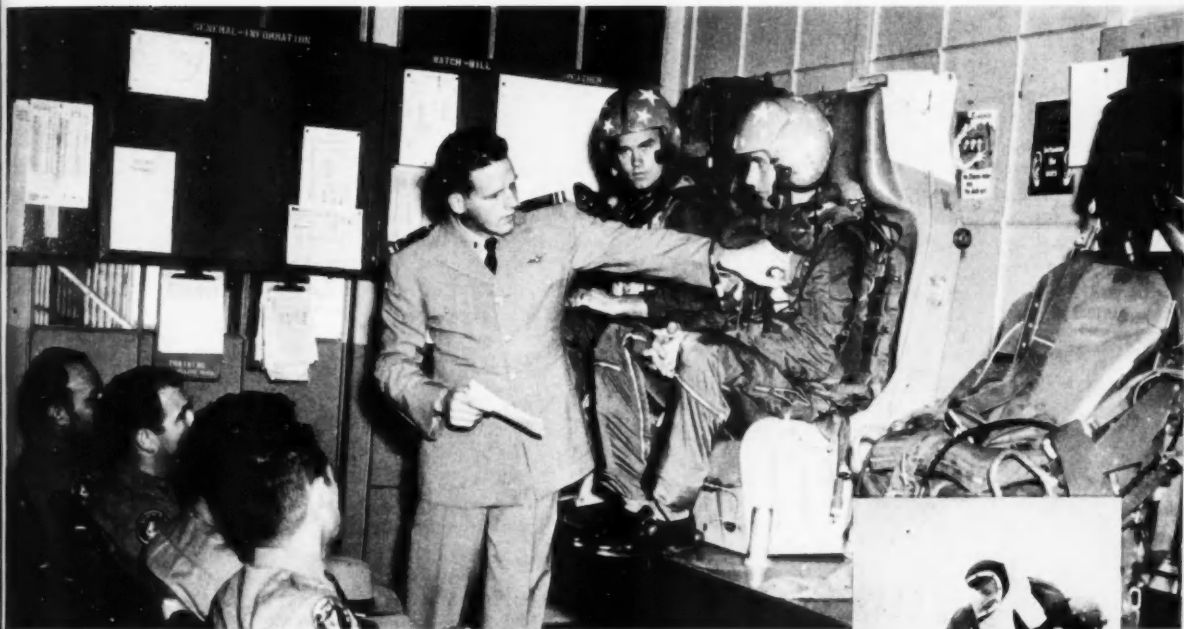
LAWMEN LEARN JET RESCUE PROCEDURES—(Above) State, county and city law enforcement officers of Jax undergo a two-hour course on jet aircraft rescue procedures as LTJG James Willis of VA-44 illustrates how to free a pilot from his parachute and ejection seat. Lawmen often are among the first to arrive on the scene of a crash, Willis told the off-duty lawmen: "It means a lot to us to know there will be somebody there who knows how to get us out of the plane."

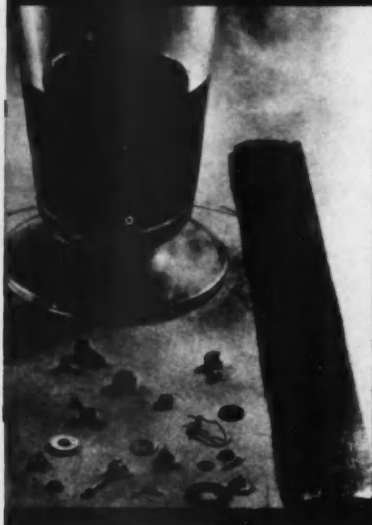
CASE NO. 748—
Contaminated Hy-
draulic fluid and
debris discovered
on acceptance check
following overhaul
of TV-2.

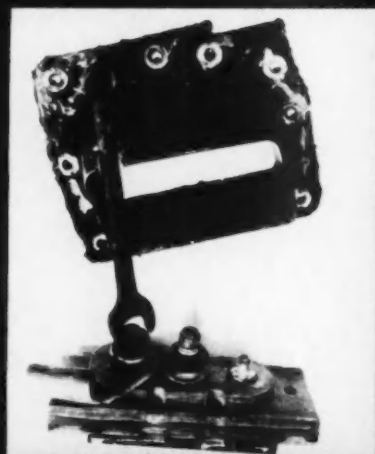
CASE NO. 977—
Wrench in FV-2
shorted out electrical
system upon con-
tacting terminal.
